Manhole Inspection Summary

Manhole # S35KK_035MH

Insp Date: **3/12/07 11:58 AM**

Location Address: **202 LAFAYETTE AVE**

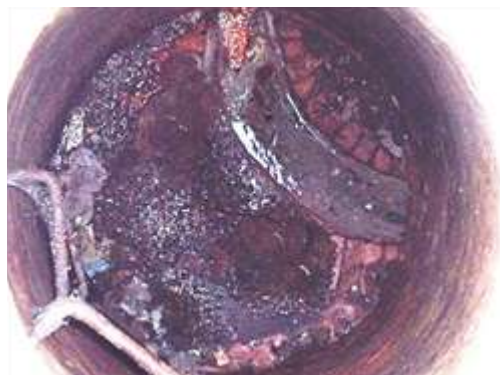
Top View

Corroded steps. Evidence of surcharge - Bench debris. Channel debris.

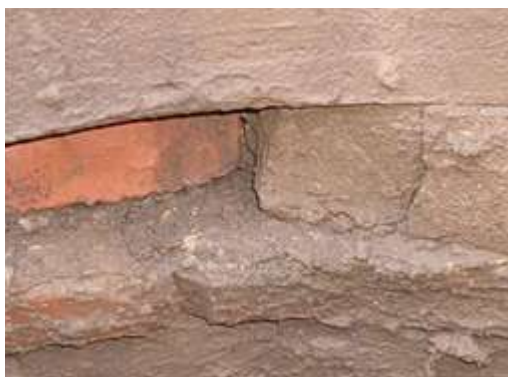
Defect

Frame Offset: **3** (in.) Condition: ☐ Sound ☐ Cracked ☒ **Leaks**

Condition: ☐ Sound ☐ Cracked ☐ Root Intrusion ☐ Loose Brick ☒ **Deteriorated**

Infiltration: ☐ None ☒ **Joint** ☐ Cracks ☒ **Mortar** ☐ Roots ☐ Wall

Frame leaks. Adjustment deterioration and infiltration.

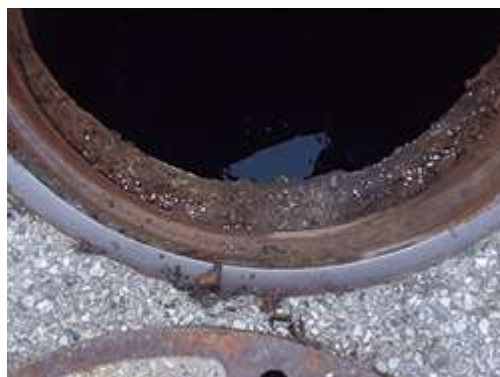
Defect

Frame leaks. Frame offset.

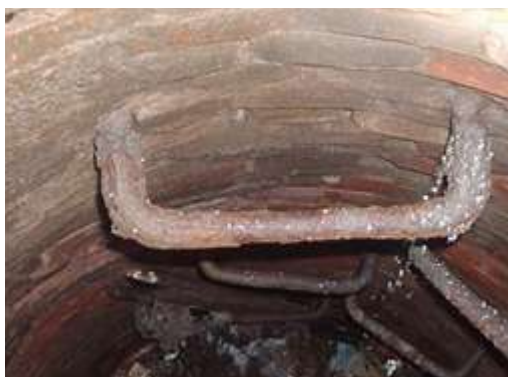
Defect

Steps Count: **5** Missing: **0** ☒ **Corroded**

Surcharge ☒ **Evidence Of Surcharge** Depth: **2** (ft.) ☐ Active Surcharge Present

Evidence of surcharge - Bench debris. Corroded steps.

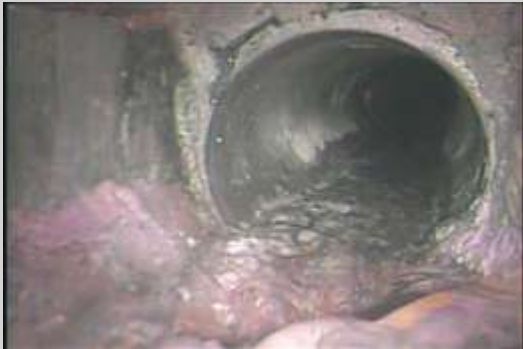
8 in. Circular Gravity Sewer Pipe Out @ 12 O'Clock

Deposits: ☐ None ☐ Mud ☐ Sludge ☐ Debris ☒ **Grease**

Silt Depth: **0** (in.) Deposits Extent: **Light**

Infiltration: **Evidence** Pipe Seal Cond: **Unknown**

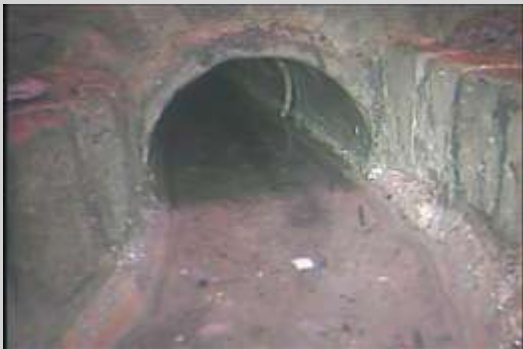
8 in. Circular Gravity Sewer Pipe In @ 3 O'Clock

Deposits: ☐ None ☐ Mud ☐ Sludge ☐ Debris ☒ **Grease**

Silt Depth: **0** (in.) Deposits Extent: **Light**

Infiltration: **Evidence** Pipe Seal Cond: **Unknown**
